The performance of low-rise open span heavy steel structures in extreme winds

The Performance of Low-Rise Open Span Heavy Steel Structures In Extreme Winds

Joe R. Charlton, B.S., P.E.

A REPORT

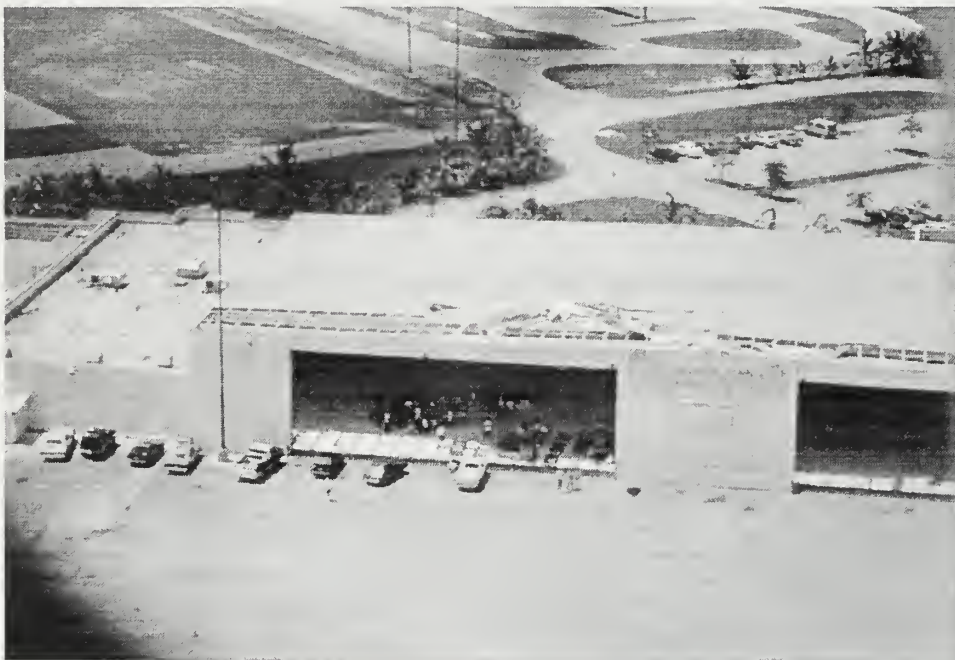
Figure 4.24 Elevation of Beechcraft Hangar

The Beechcraft hangar shown in Figures 4.23, 4.24, and 4.25 is approximately 200 feet long, 60 feet wide, and 40 feet tall. The structure has a gable roof with a very slight pitch (approximately 1/4" per foot). The exterior walls are covered with corrugated metal siding and the roof is covered with corrugated metal decking. The main structural system is made up of wide flange steel columns, large custom girders, and z shape roof purlins. The lateral loads are transferred to the foundation via steel cross bracing running between the columns. All of the main structural elements can be seen in Figure 4.25. The other two hangars that are shown in Figure 4.26 are very similar in size and construction to the Beechcraft hangar.
